Seatbelt submarining injury and its prevention countermeasures: How a cantilever seat pan structure exacerbate submarining

Chandrashekhar K. Thorbole¹

¹Director, Thorbole Simulation Technologies LLC, Rogers, Arkansas 72758, USA

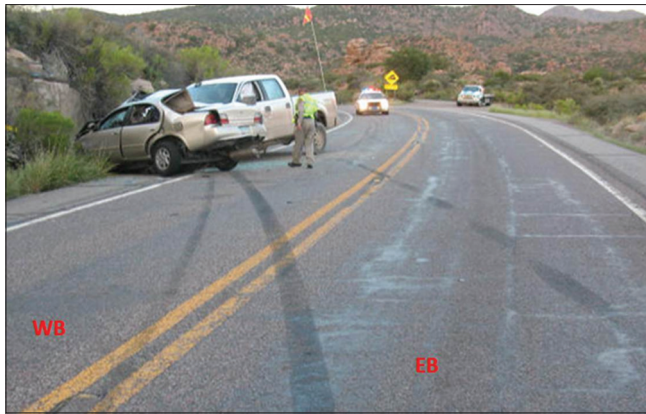
Figure 1: Crash location and vehicle orientation postcrash scene (Arizona police file)

The 61-year-old Hispanic male sustained critical abdominal and thorax injuries in the frontal crash. Figure 1 shows the crash location and vehicle orientation postcrash. He was seated in

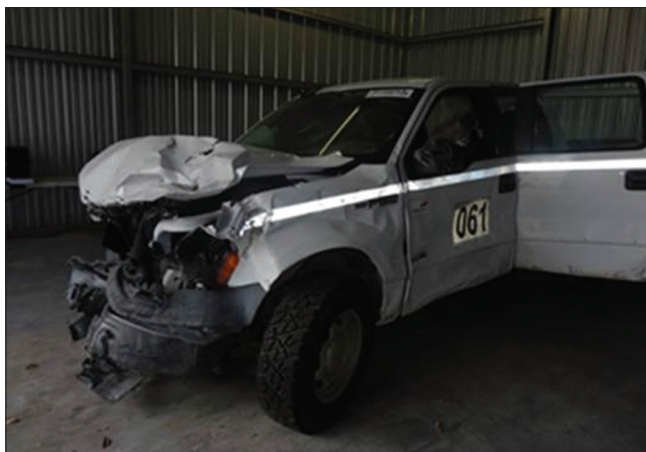
the right rear seat position of the pickup (a small truck with an enclosed cab and open back). The seat at this location featured a cantilever type seat pan structurally unsupported at the front end as shown in Figure 2. Figure 3 shows the pickup frontal damage. He was complaining, “my stomach and chest hurts” at the crash scene based on the emergency medical service responders report. This report also indicates the presence of positive lap and shoulder belt bruising on the occupant. The computed tomography (CT) scan study at the hospital revealed grade 5 liver laceration with small bowel perforation and left first, second, third and fourth rib fractures with pneumothorax as shown in Figure 4. He also sustained associated right C7 transverse process fracture with no cerebrovascular injuries. Head and neck CT studies were unremarkable. Table 1 shows his injury severity as per the Abbreviated Injury Scale (AIS) scale, and Table 2 shows several operative procedures conducted on him in the hospital. He expired after 20 days of treatments and operations in the hospital. He developed septic shock and progression of his liver failure.

Figure 3: The subject vehicle frontal crush profile (original)

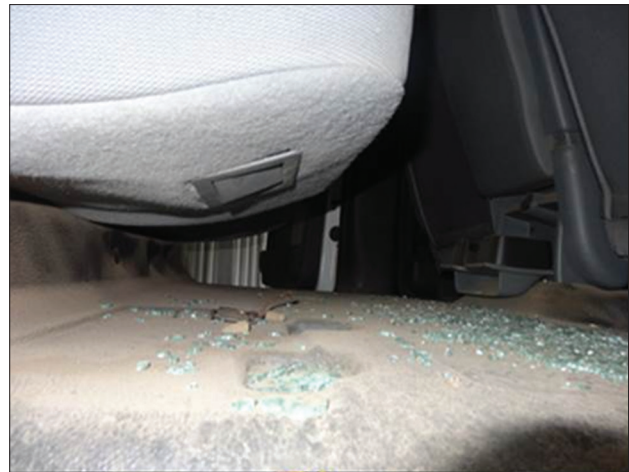
Figure 2: Second row cantilever seat pan design in the pickup involved in the crash (original)

A stiff fixed contoured anti-submarining seat pan with a seat belt equipped with load-limiter and pretensioner is the best countermeasure to tackle occupant submarining and subsequent abdominal injuries. The stiffer fixed, properly supported seat pan, instead of a cantilever seat pan would have prevented the downward deflection of the pan while the forward excursion of the pelvis. This downward dynamic deflection worsened the lap belt riding on the abdomen. This knowledge will assist Indian automotive design

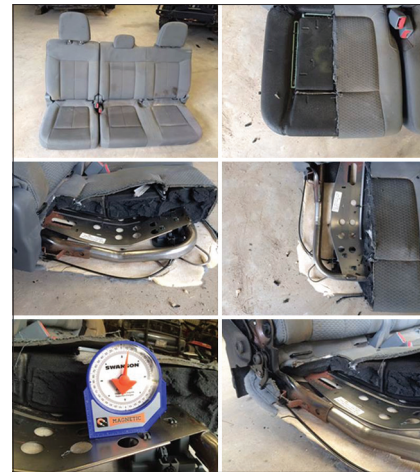
Figure 6: Investigation of the seat pan structure of the similar vehicle (original)
